# Inspection Report

## American Homebuyer

**Property Address:**  
200 Pleasant Street  
Hometown RI 02837

**Hearthstone Home Inspection**

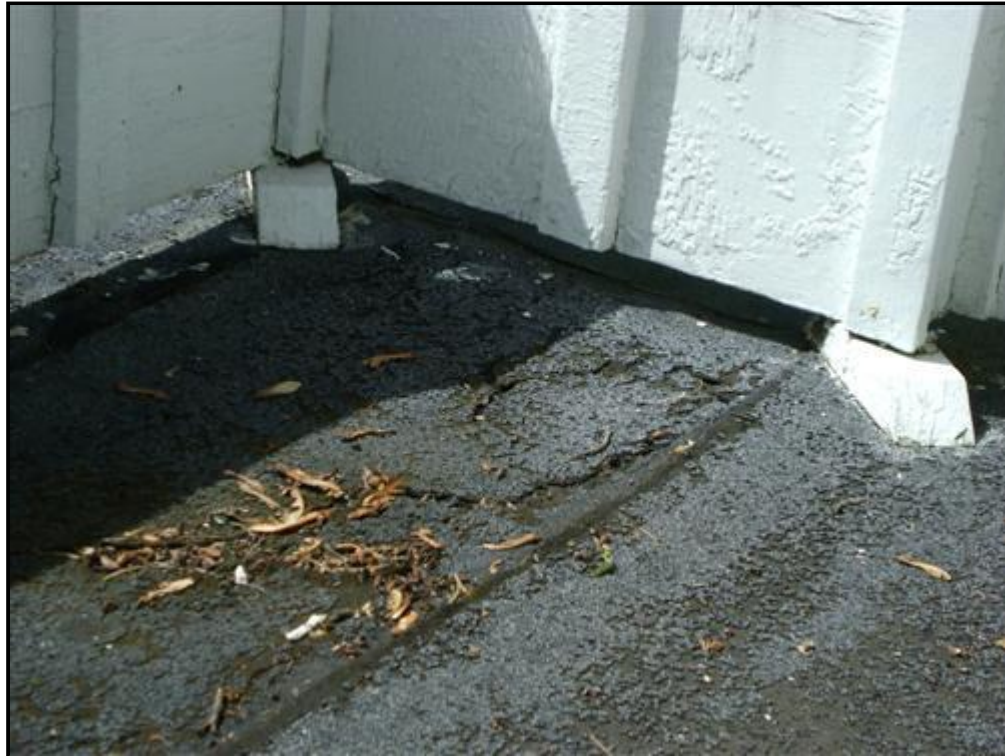
There is some blistering on the tar and gravel roof over the kitchen area. The rolled roofing over the front entrance is deteriorated and cracked. The scuttle opening through the roof does not appear to be properly secured through the roof (no visible flashing or other means to prevent leaks). There is caulking on the outside of the scuttle which has separated/cracked. I recommend evaluation and repairs by a roofer.

1.0 Picture 1 Deteriorated roofing- over front entrance way.

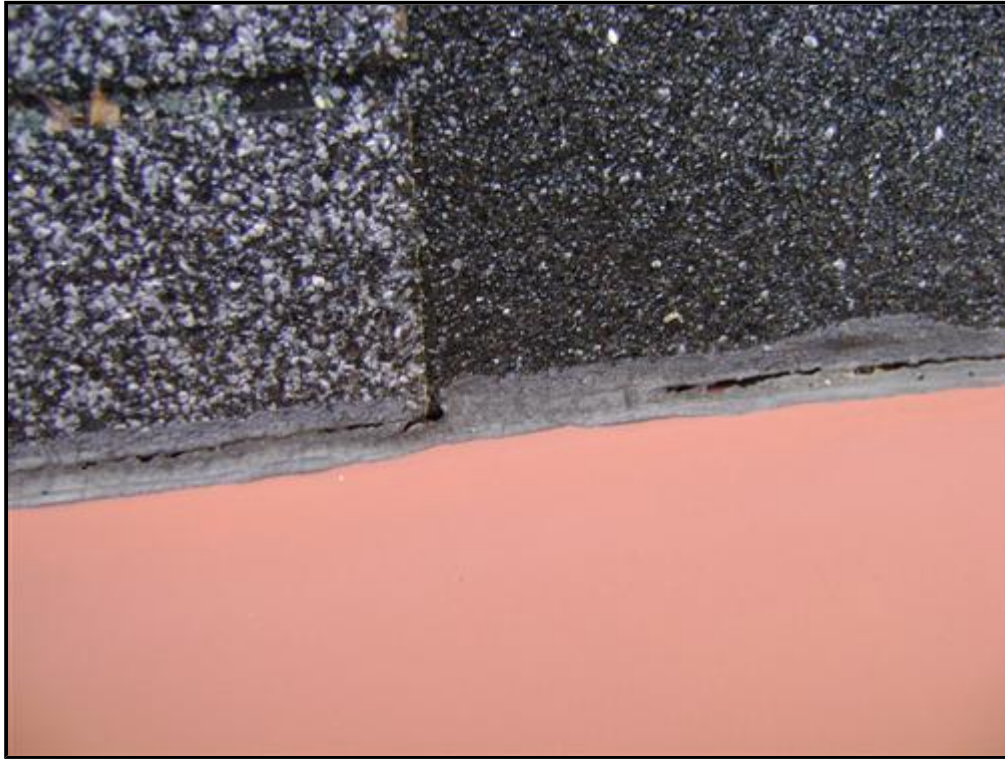
1.0 Picture 2 Openings in caulking and no flashing around scuttle

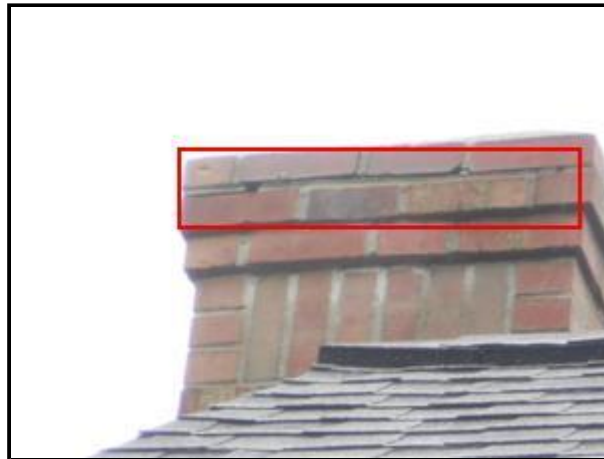
The mortar joints at the top of the chimney are deteriorated and in need of repointing by a qualified mason or chimney sweep.

1.2 Picture 1 Deteriorated mortar joints

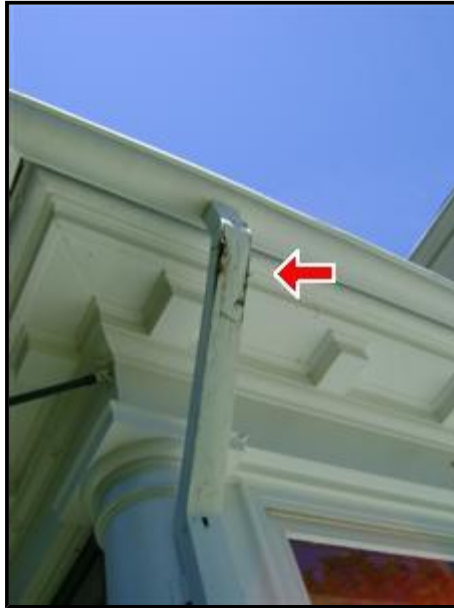
There are deteriorated sections of the copper gutters and downspouts, especially on the downspouts for the sun room. I recommend repairs or replacement. The older copper gutters thin as they age- anticipate the need for regular maintenance and repairs.

1.3 Picture 1 Deteriorated downspout.

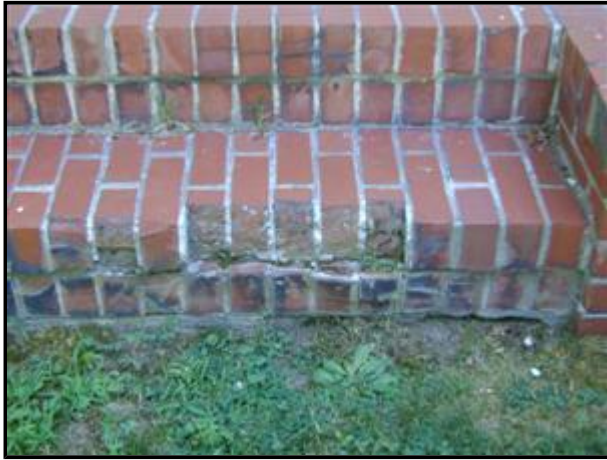
The front brick steps are deteriorated and in need of repairs by a qualified mason.

2.3 Picture 1 Deteriorated front steps.

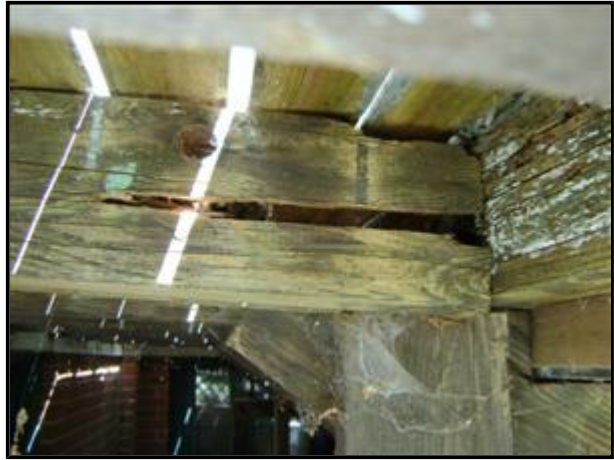
There is deterioration under and around a rear column on the side porch. There is also deteriorated to the deck boards and framing under the wooden steps at the rear of the sun room. I recommend having railings with closely spaced balusters installed for the decks and steps. Contact a qualified carpenter for repairs and installation of the railings.

2.3 Picture 2 Deteriorated framing under sun room steps.

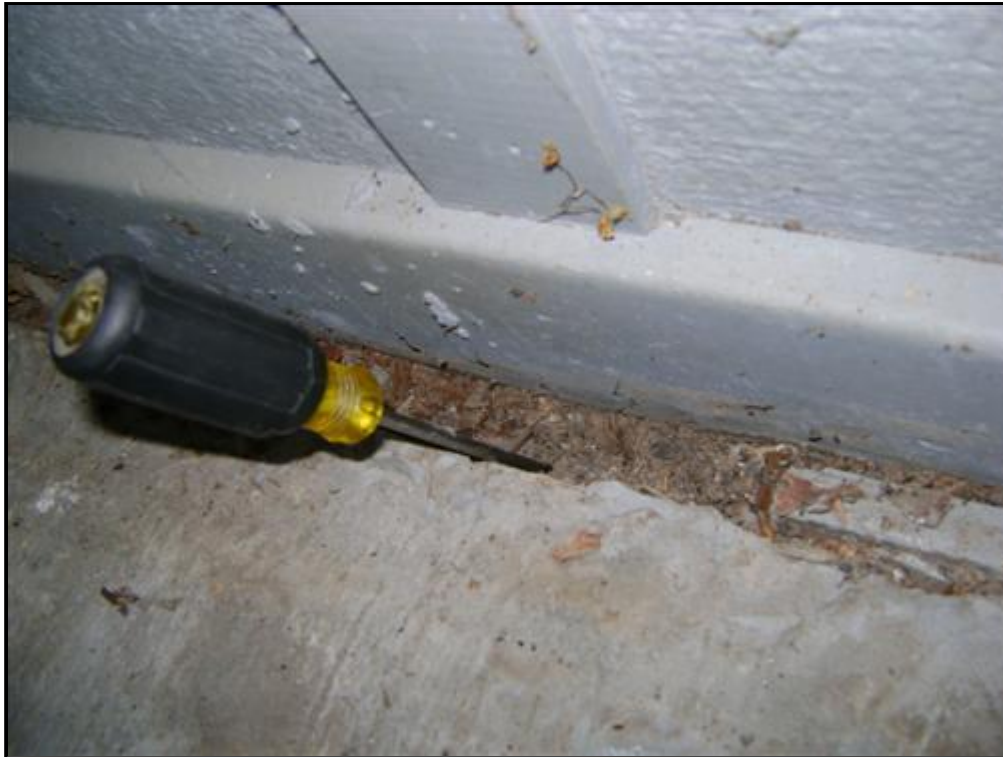
There are areas of deteriorated sill on the right side of the garage. There are some sections of the sill which were inaccessible during the inspection. I recommend evaluation and repairs of the sill by a qualified carpenter.

3.1 Picture 1 Deteriorated sill in garage.

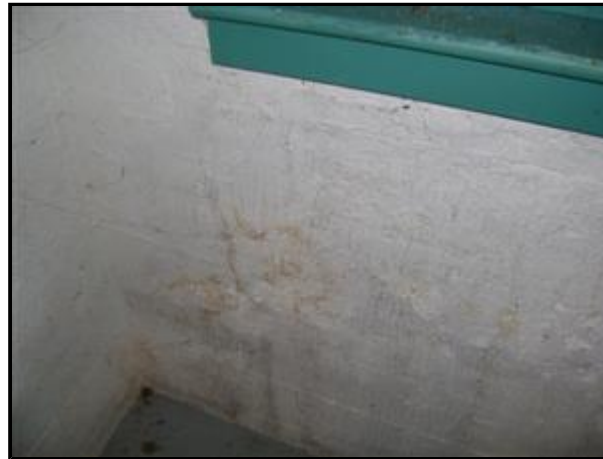
There are moisture and/or water stains in areas of the basement, indicating past water or moisture penetration, or past water leaks, in the basement. To limit moisture and water entering the basement it is important to have proper grading on the exterior around the house, keep gutter systems clean and downspouts extended away from foundation.

5.0 Picture 1 Water stains on basement wall.

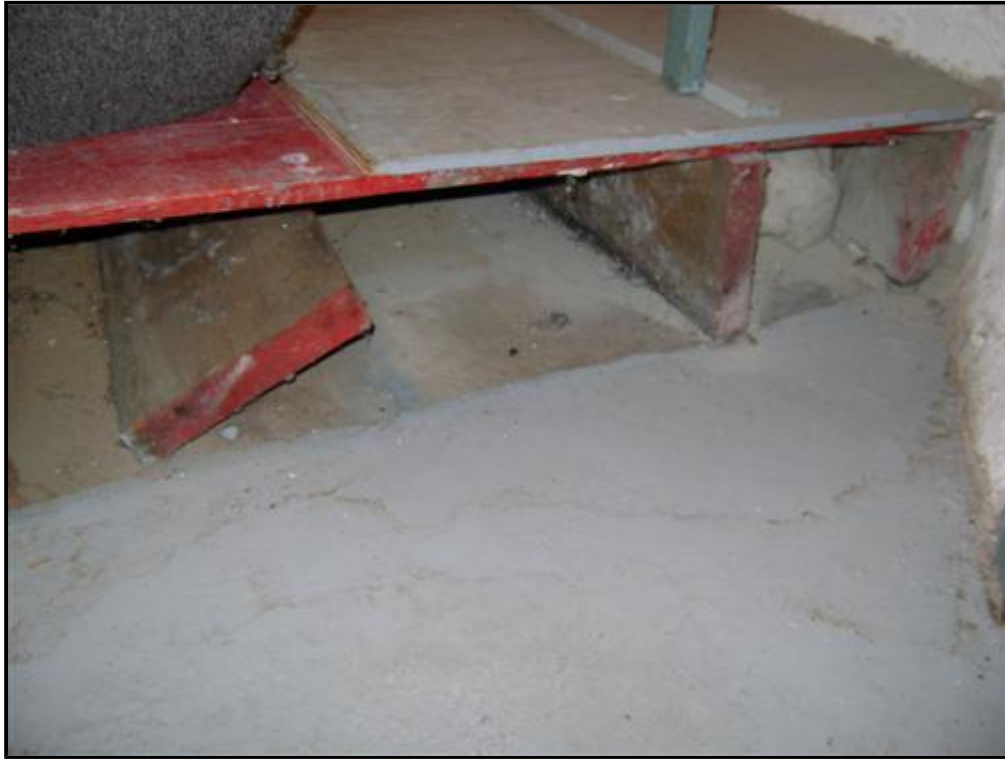
The basement laundry room floor has loose and fallen floor joists. I recommend repairs by a qualified carpenter.

5.2 Picture 1 Fallen joist- laundry room floor.

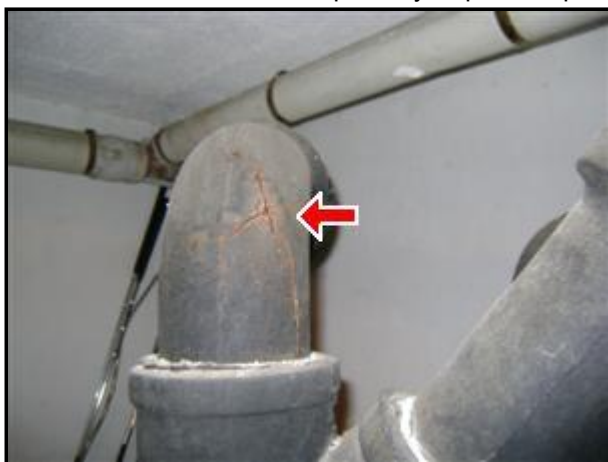
- There are cracks in cast iron waste lines in the basement and uncapped waste lines in the basement. I recommend evaluation and repairs by a qualified plumber.

6.0 Picture 1 Cast iron waste line in basement.

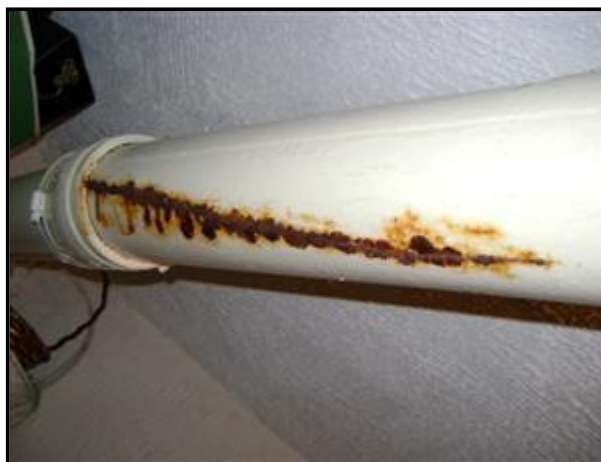
6.0 Picture 2 Cracked waste line in basement.

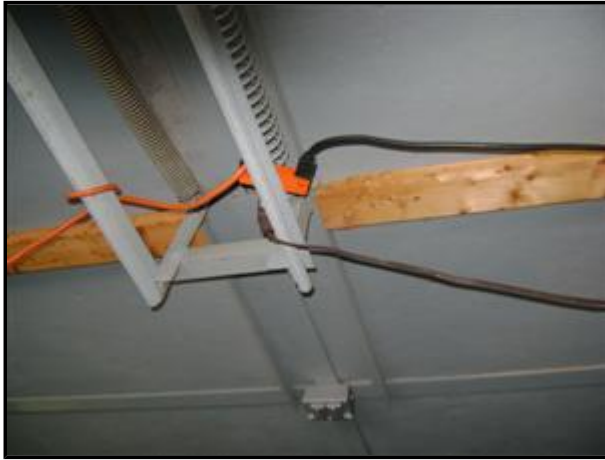
There are cut wires above the side door. Extension cords are used to power the openers in the garage. The wire feeding from the house to the garage is low over the driveway and there are open splices on the garage exterior. The electric dryer wire runs along the floor in the laundry room under a rug. There are open wire splices in the attic and the attic fan did not turn on- contact an electrician for evaluation and repairs.

7.3 Picture 1 Extension cords used in garage.

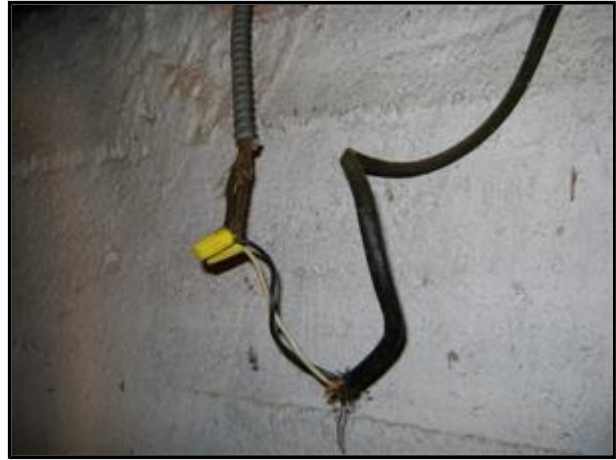
There are cut wires, open junction boxes and open wire splices in the basement. I recommend evaluation and repairs by a qualified electrician.

7.3 Picture 2 Open wire splice in basement.

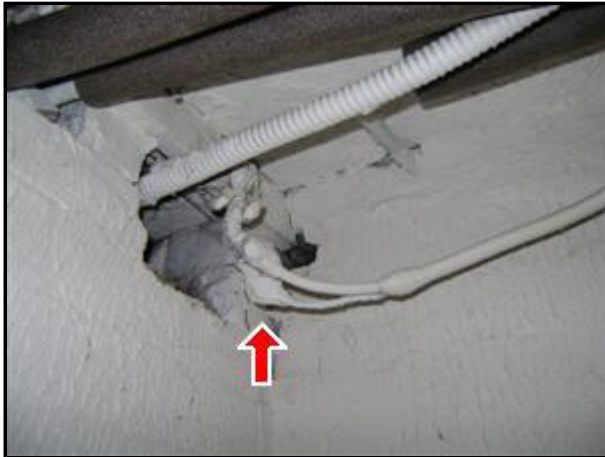
7.3 Picture 3 Open wire splices in basement

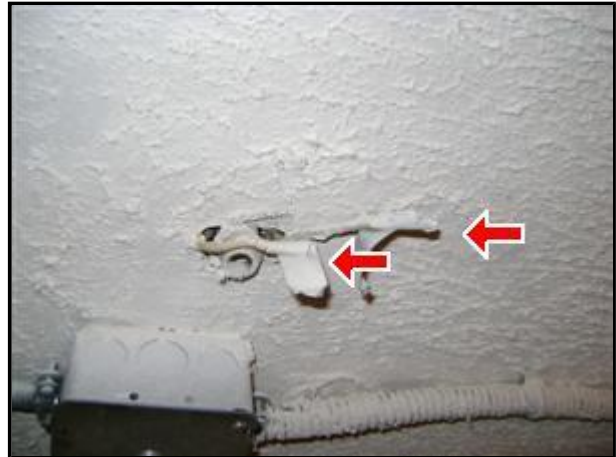
7.3 Picture 4 Cut/taped wires in basement ceiling (live).

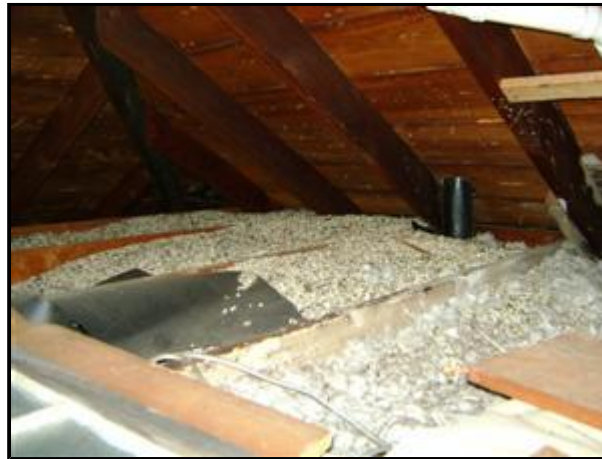
Vermiculite insulation in the attic- this may contain asbestos. The EPA recommends not disturbing this insulation. For all the EPA recommendations please visit: <http://www.epa.gov/asbestos/pubs/insulation.html>

9.0 Picture 1 Vermiculite insulation in attic.
